Technical Bulletin

2017+ B&B Wreckers /w Walvoil SDS140 Valve System

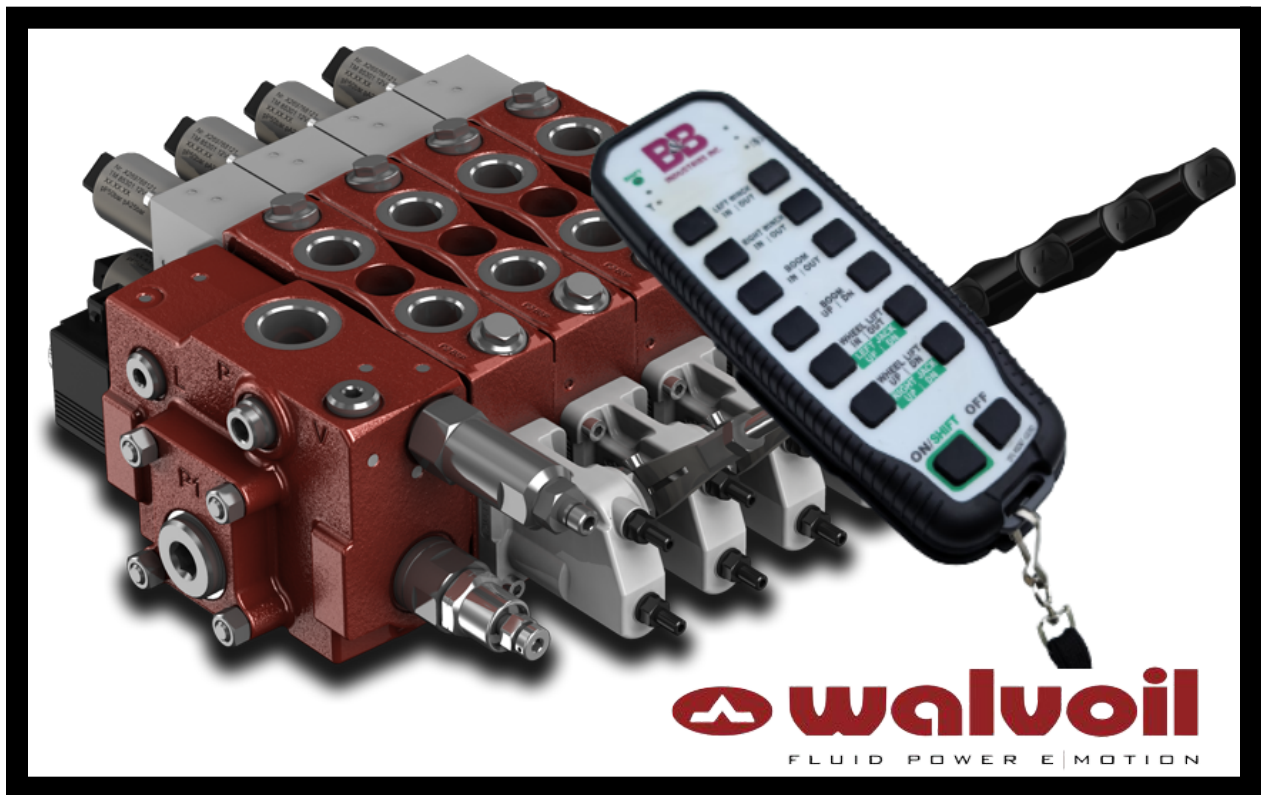
This flaw has gone unnoticed since these systems were introduced in 2017, and affect all units that were built with Walvoil SDS140 Valve System /w Scanreco Rocket Remote (shown in picture above).

The Walvoil SDS140 Valve that was installed on the units has a High Pressure Carry Over Plug from the manufacturer. This caused the hydraulic system to always be under pressure and was unable to operate at peak performance from installation.

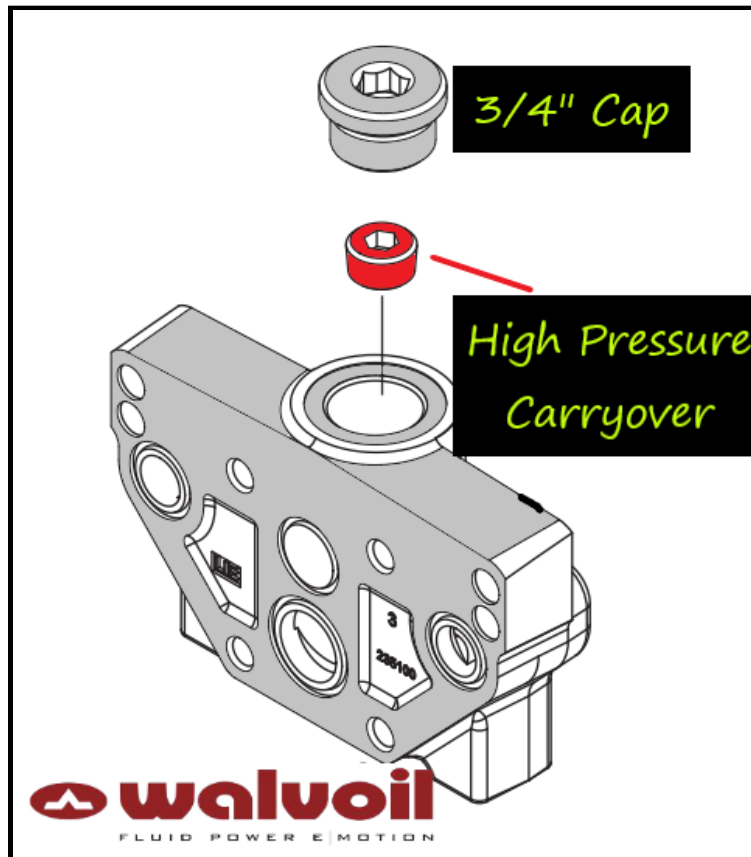
The High Pressure Carryover plug was meant for Single Pump / Dual Valve Body configuration. In this configuration, the 1st valve body (left) needs this plug to be installed to carry over high pressure to the secondary valve body (right). The High Pressure Carry Over plug **SHOULD NOT be installed** on the secondary (right) valve body, if installed it will cause these issues to arise.

The High Pressure Carryover plug **SHOULD NOT** be installed on either 1st(left) or secondary(right) valve body. With a Dual Pump / Dual Valve Body configuration, both valve bodies have their own pressure supply coming from a dedicated pump (dual pump), if these High Pressure Carryover plugs are installed on either valve bodies, it will cause these issues to arise.

1. On the Outlet Side (right side) of the valve body, remove the top 3/4" cap or attachment connected.
2. Remove the High Pressure Carryover plug located directly below the 3/4" cap. **If missing the problem has most likely been fixed previously.**
3. Replace 3/4" cap / attachment

*Note: In the past, owners were directed to turn up the valve body pressure as a fix to this issue, if the valve body pressure was previously turned up to compensate for this issue, it must be turned back down to the OEM pressure of **3200 PSI / GPM 20**. This should be tested and verified by a professional hydraulic shop / technician.
